**Melvin Price Locks and Dam UMR Mile 201**  
**Auxiliary Miter Gate Failure**  
**Weekly Status Report**  
**27 January 2005**

**General Description:** On 3 Oct 2004 the downstream miter gates on the auxiliary lock at Melvin Price Locks & Dam traveled past the mitered position, causing severe damage to the gates.

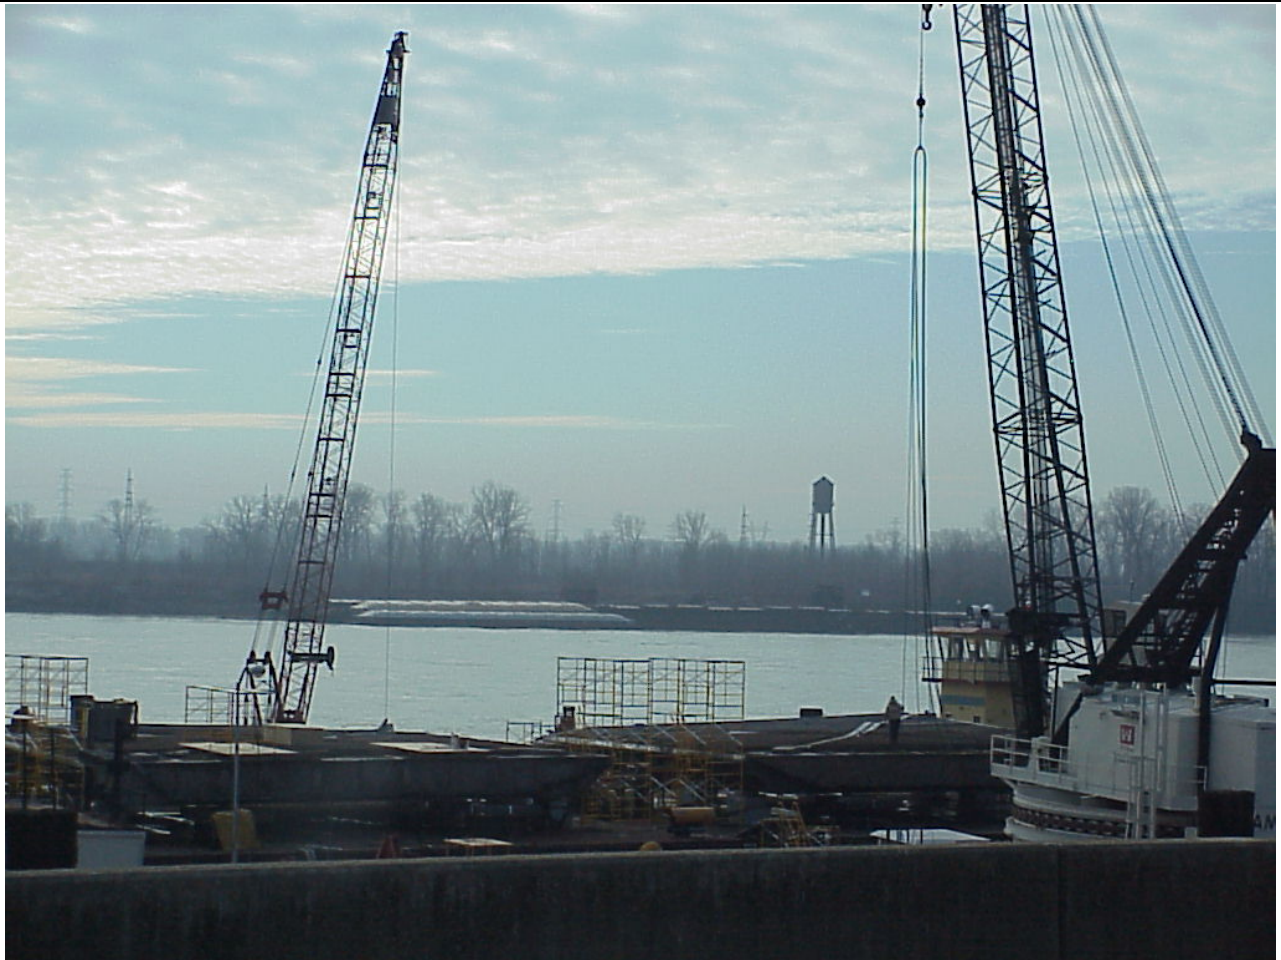
300' by 82' barge and two heavy cranes support gate leaf repairs at the District Service Base

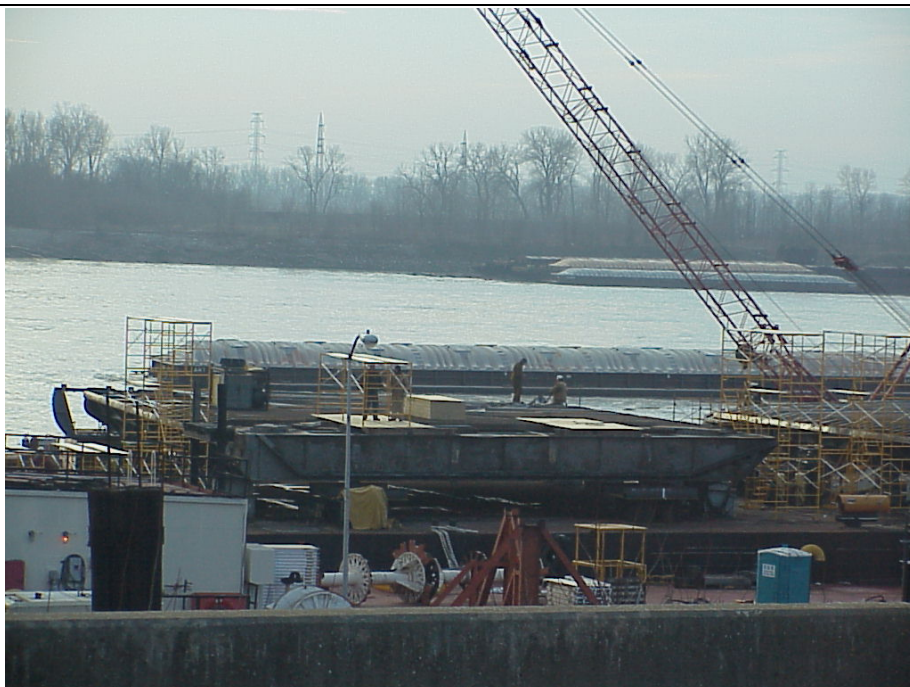
Service Base Combined Team crews working on Missouri Leaf diagonal straps and plates

- Installed temporary enclosures in repair locations on gate leafs
- Onsite inspection of work by potential heat straightening contractors.
- Removed diagonal straps from both leafs
- Removed diagonal plates from Missouri leaf
- Continued preparing gate barge for environmental enclosure
- Removed lower shoes from both leafs
